# Road Pavement Failure of Flexible Pavement from Sanat-Nagar to Pantha-Chowk

## Abstract

My project is related to the failure of the flexible pavement stretch of road from Sanat-Nagar to Pantha-Chowk Srinagar Jammu and Kashmir India. In my project, I will study the various pavement failures which have occurred on flexible pavement mainly due to rains, snow and recent floods. This road stretch is located on NH-1A and is 8.5 km in length. It is a four lane two way divided carriageway. It is 18 m wide (7.5+7.5+3.0).

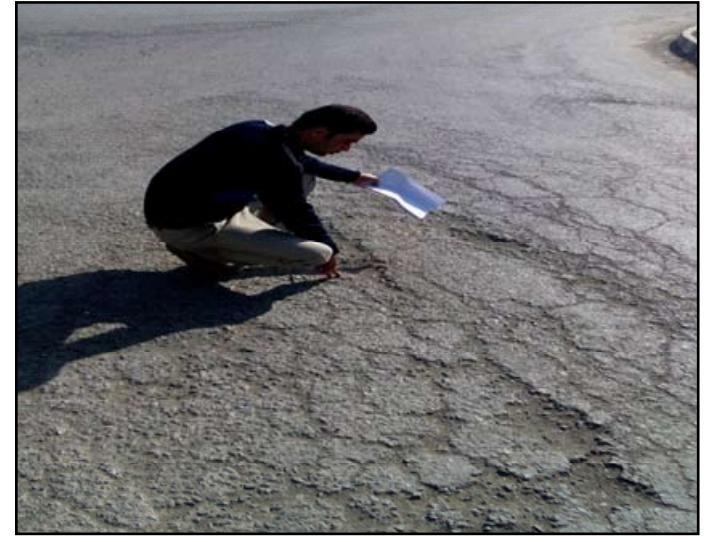
## **Fatigue Cracking**

**Description:** Series of interconnected cracks caused by fatigue failure of the HMA surface (or stabilized base) under repeated traffic loading. In thin pavements, cracking initiates at the bottom of the HMA layer where the tensile stress is the highest then propagates to the surface as one or more longitudinal cracks. This is commonly referred to as "bottom-up" or "classical" fatigue cracking. In thick pavements, the cracks most likely initiate from the top in areas of high localized tensile stresses resulting from tire-pavement interaction and asphalt binder aging (top down cracking). After repeated loading, the longitudinal cracks connect forming many-sided sharp-angled pieces that develop into a pattern resembling the back of an alligator or crocodile.

• **Problem:** Indicator of structural failure, cracks allow moisture infiltration, roughness, may further deteriorate to a pothole.

• **Possible Causes:** Inadequate structural support, which can be caused by a number of things. A few of the more common ones are listed here:

- Loss of base, subbase or subgrade support (e.g., poor drainage or spring thaw resulting in a less stiff base).
- Stripping on the bottom of the HMA layer (the stripped portion contributes little to pavement strength so the effective HMA thickness decreases)
- Increase in loading (e.g., more or heavier loads than anticipated in design)
- Inadequate structural design
- Poor construction (e.g., inadequate compaction)

• **Repair**: A fatigue cracked pavement should be investigated to determine the root cause of failure. Any investigation should involve digging a pit or coring the pavement to determine the pavement's structural makeup as well as determining whether or not subsurface moisture is a contributing factor. Once the characteristic alligator pattern is apparent, repair by crack sealing is generally ineffective. Fatigue crack repair generally falls into one of two categories:

- Small, localized fatigue cracking indicative of a loss of subgrade support. Remove the cracked pavement area then dig out and replace the area of poor subgrade and improve the drainage of that area if necessary. Patch over the repaired subgrade.
- Large fatigue cracked areas indicative of general structural failure. Place an HMA overlay over the entire pavement surface. This overlay must be strong enough structurally to carry the anticipated loading because the underlying fatigue cracked pavement most likely contributes little or no strength.

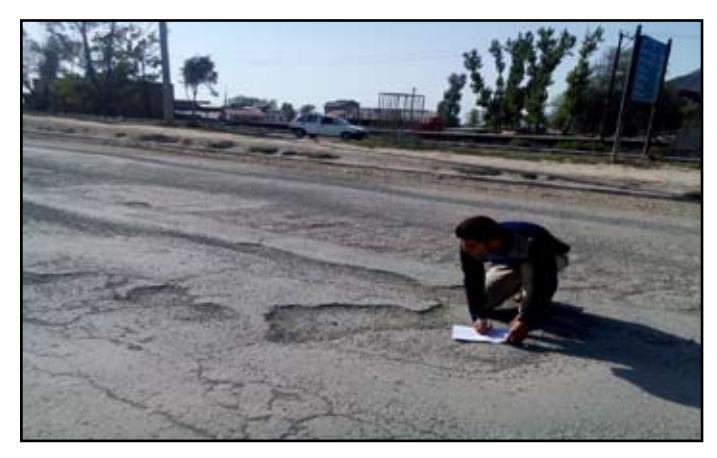
#### Potholes

• **Description:** Small, bowl-shaped depressions in the pavement surface that penetrate all the way through the HMA layer down to the base course. They generally have sharp edges and vertical sides near the top of the hole. Potholes are most likely to occur on roads with thin HMA surfaces (25 to 50 mm) and seldom occur on roads with 100 mm or deeper HMA surfaces.

• **Problem:** Roughness (serious vehicular damage can result from driving across potholes at higher speeds), moisture infiltration.

• **Possible Causes:** Generally, potholes are the end result of alligator cracking. As alligator cracking becomes severe, the interconnected cracks create small chunks of pavement, which can be dislodged as vehicles drive over them. The remaining hole after the pavement chunk is dislodged is called a pothole.

• Repair: Patching.

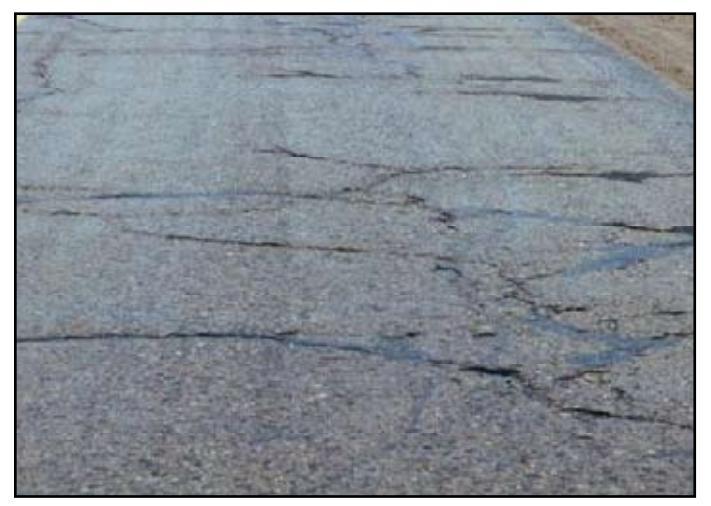
#### **Block cracking**

• **Description:** Interconnected cracks that divide the pavement up into rectangular pieces. Blocks range in size from approximately 0.1 m2 to 9 m2. Block cracking normally occurs over a large portion of pavement area.

• Problem: Roughness, Allows moisture infiltration.

• **Possible Causes:** HMA shrinkage and daily temperature cycling. Typically caused by an inability of asphalt binder to expand and contract with temperature cycles because of asphalt binder aging.

Poor choice of asphalt binder in the mix design

• **Repair**: Strategies depend upon the severity and extent of the block cracking:

- Low severity cracks (< 12 mm wide). Crack seal to prevent</li>
  (1) entry of moisture into the structure through the cracks and
  (2) further ravelling of the crack edges. HMA can provide years of satisfactory service after developing small cracks if they are kept sealed.
- High severity cracks (> 12 mm wide and cracks with ravelled edges). Remove and replace the cracked pavement layer with an overlay.

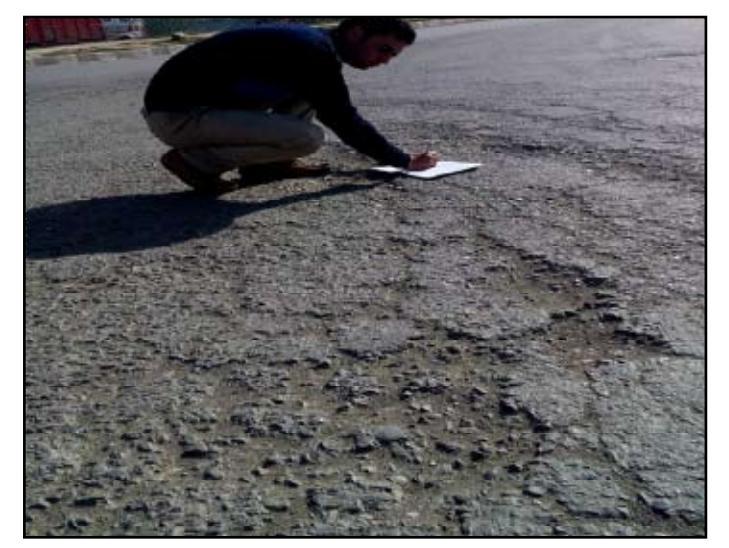
#### Depressions

• **Description:** Localized pavement surface areas with slightly lower elevations than the surrounding pavement. Depressions are very noticeable after a rain when they fill with water.

• **Problem:** Roughness, depressions filled with substantial water can cause vehicle hydroplaning.

• **Possible Causes:** Irregular frost heave or subgrade settlement resulting from inadequate compaction during construction or poor quality (soft) subgrade.

• **Repair**: By definition, depressions are small localized areas. A pavement depression should be investigated to determine the root cause of failure (i.e., subgrade settlement or frost heave). Depressions should be repaired by removing the affected pavement then digging out and replacing the area of poor subgrade. Patch over the repaired subgrade.
